DISTRICT OF TUMBLER RIDGE

WATER SYSTEM ANNUAL REPORT 2019

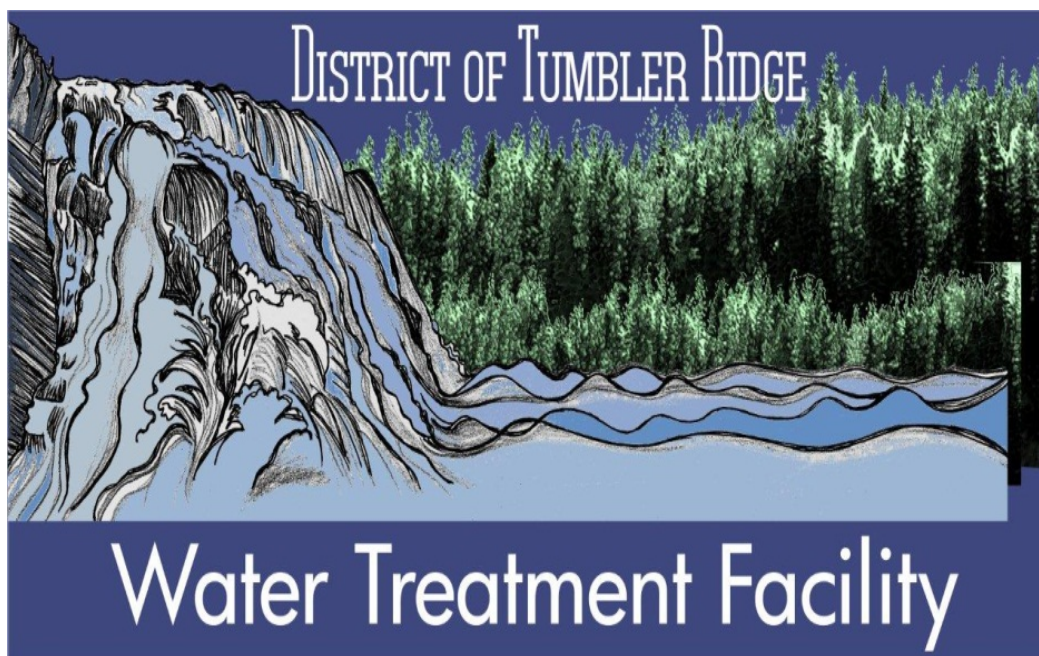
Figure 1 Displays the overall Water system.

The District's community water system has several sources, including two high production groundwater well sources at Flatbed Creek (Wells 7 & 8), which are the primary supply wells for the community water system. Two other wells off Highway 52 supply water to the Industrial Park, and are used to supplement flows from Wells 7 & 8 during high water demand situations.

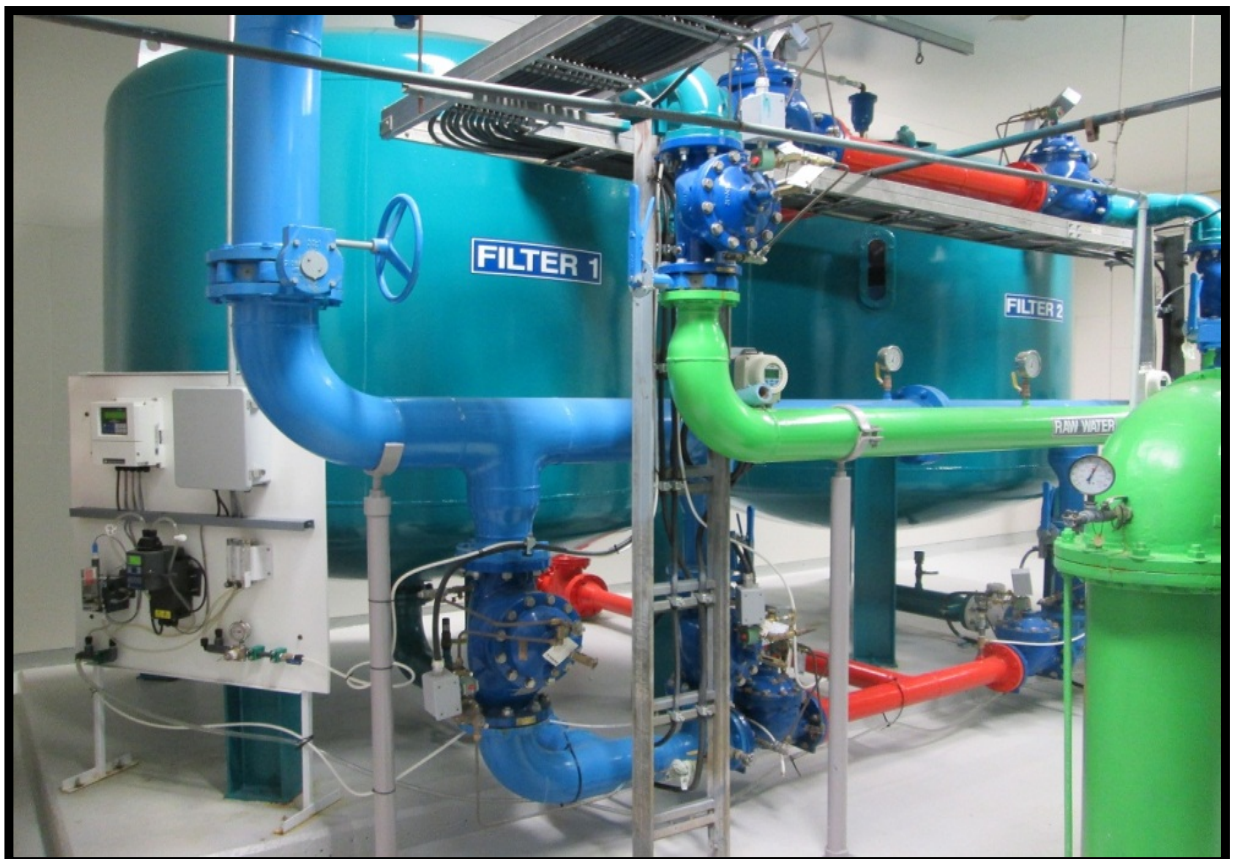
The District also has two additional, lower capacity wells (1 & 3) that can provide water to the main community system if required for high demand situations (e.g. golf course watering), but are primarily used to supply water to the Tumbler Ridge Industrial Park.

Water from Wells 1 and 3 are pumped to distribution system/reservoirs, where they mix with chlorinated water from the water treatment plant.

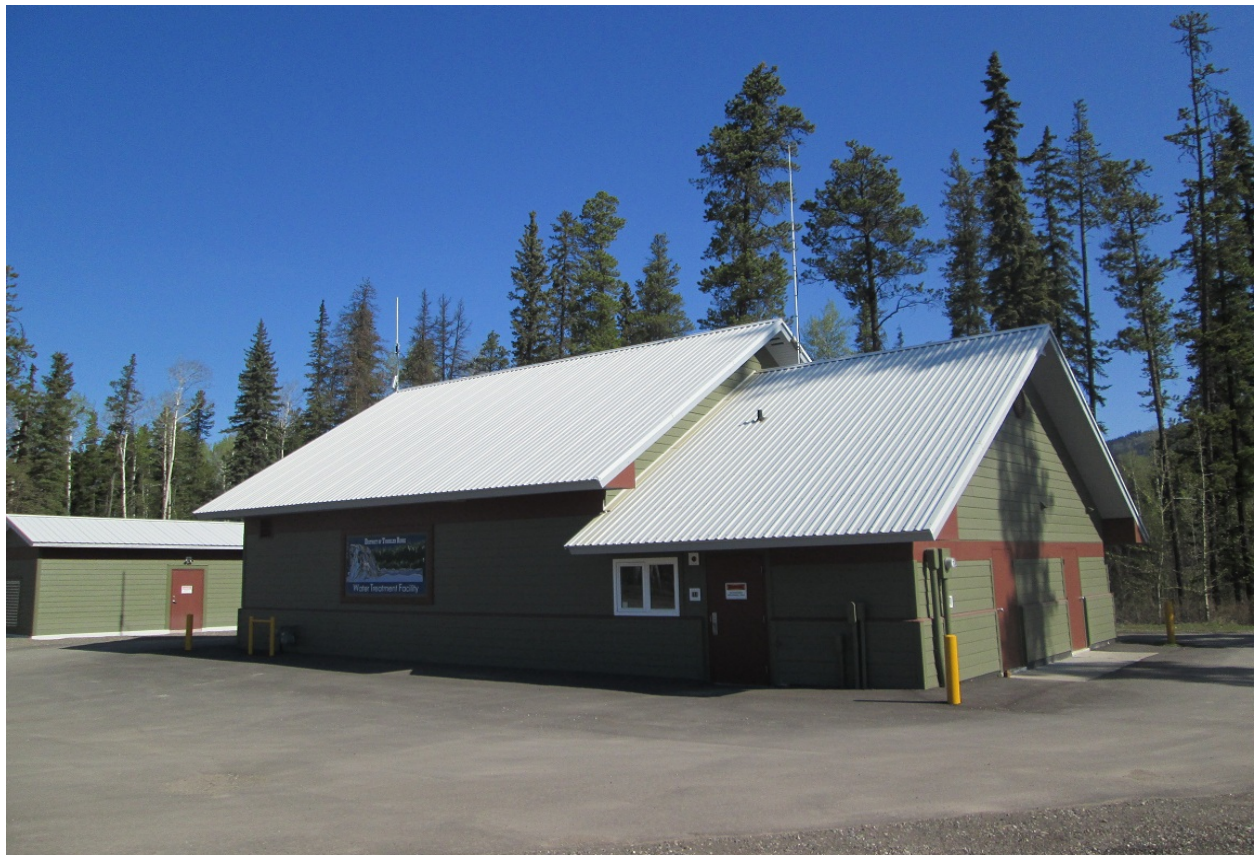
2.3 Water Treatment Plant

The Water Treatment Plant (WTP) is located on Pioneer Loop and treats water from Wells 7 & 8. A dedicated water-main transmits water from the wells to the WTP. The water treatment process consists of pre-treatment using chlorine followed by filtration through manganese greensand filters for removal of iron and manganese. The water is then chlorinated to maintain a residual in the distribution system and ensure that good microbiological water quality is maintained all the way to consumers' taps.

The system then pumps to the reservoir from which water is fed to the majority of the developed community.

As the filtration system and wells are getting older, further work is recommended in the near future to assess the infrastructure and determine whether upgrades or system maintenance is required. This could include replacement of the filter media or optimization of the chemical pre-treatment process to achieve better removals of manganese.
